ASTARTE

Deliverable 5.3

Lessons From Recent Tsunamis Impacts on Coastal and Marine Structures and Coastal Utilities, and Performance of Mitigation Strategies

Work Package:	5 "Tsunami-Coastal Impacts"
Lead beneficiary of this deliverable:	METU
Author(s):	Deniz Can AYDIN, Gözde Güney DOĞAN, Gülizar ÖZYURT TARAKCIOĞLU, Ahmet Cevdet YALCINER, and Nilay DOĞULU.
Version:	V2.6

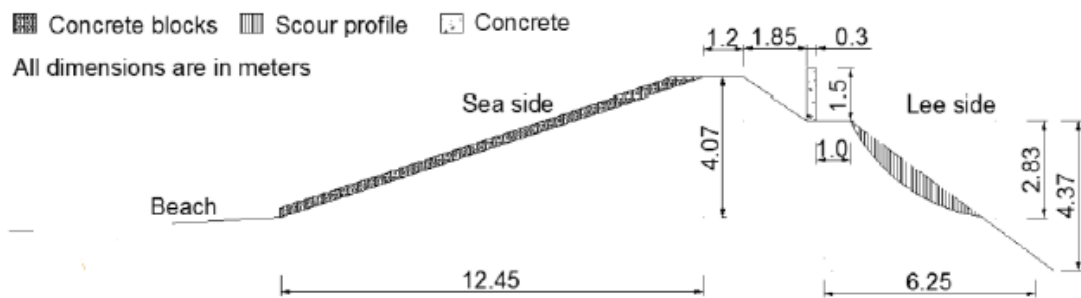
One group of the researchers, Jayaratne et al. (2013) have investigated coastal structure failures due to the 2011 Great Eastern Japan Earthquake Tsunami in Miyagi and Fukushima prefectures and found out that the major reason for failure of many sea dikes was due to scour created by overtopping waves in leeward and slope. Once the leeward is scoured, it exposes gravel and sand core to rapid flow and causes sea dikes to be washed away. Surveyed scour profiles of the studied sea dikes can be seen in Figure 6, 7, and 8.

Figure 6: Sea dike at Soma City (north side) (Jayaratne et al., 2013).

To strengthen sea dikes that encounter overtopping tsunami, the authors conclude that leeward side and toe should be reinforced against increased water velocity and vorticity. In order to do this, it is suggested to use impermeable concrete structures on the leeward side and heavy concrete for the toe that extends over a wide area.

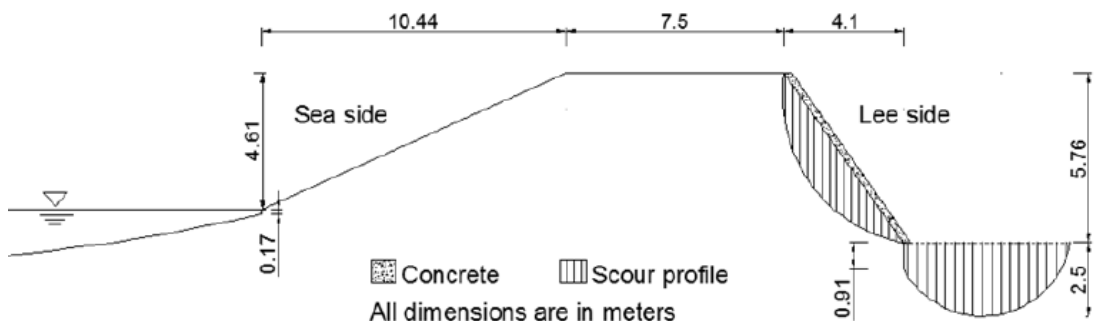
Figure 7: Sea dike at Iwanuma City (Jayaratne et al., 2013).

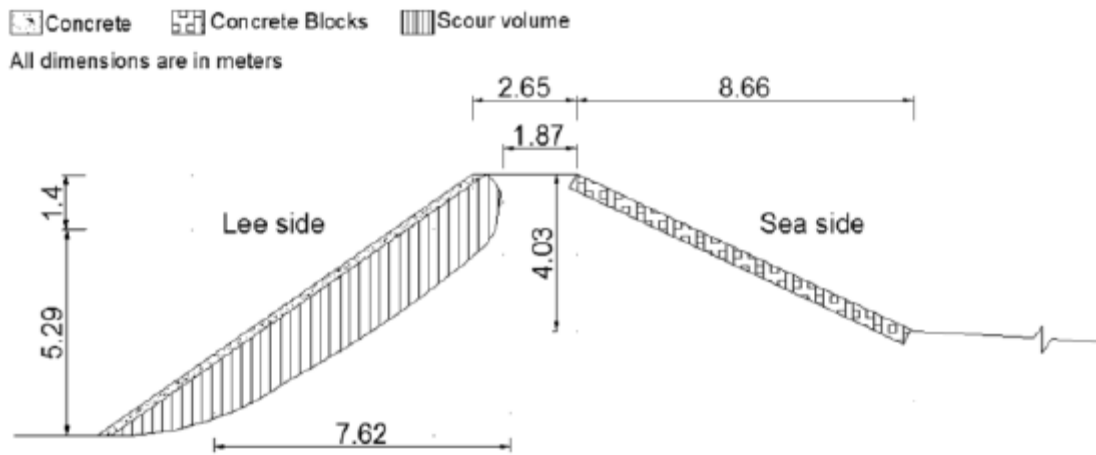
Figure 8: Sea dike at Yamamoto City (Jayaratne et al., 2013).

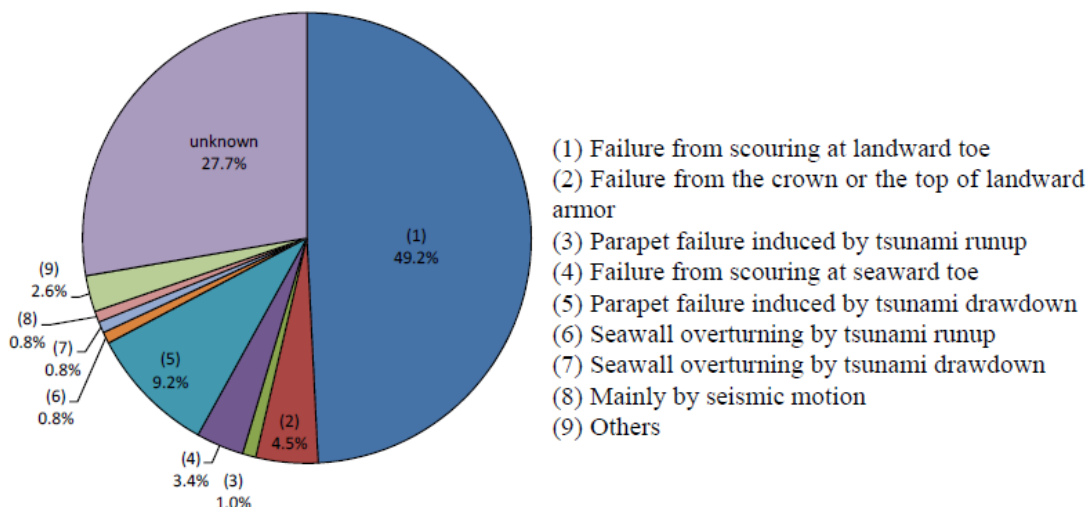
Kato et al. (2012) have studied the mechanisms of coastal dike failure induced by the GEJE by means of field surveys and hydraulic model experiments and classified the results into eight failure patterns. Failure patterns for the coasts between Aomori and Chiba prefecture were judged for a total length of 99 km damaged coastal dike. Same as Jayaratne et al. (2013) they also found out that primary failure pattern was from scouring at landward toe with a ratio of 49.2%. Second most observed pattern was failure from the crown or the top of landward armor which is caused by negative pressure acting on the landward armor during fast flow. The proportions of different failure patterns found in the study are provided in Figure 9.

Figure 9: Proportion of each failure pattern along the length of damaged coastal dike (Kato et al., 2012).

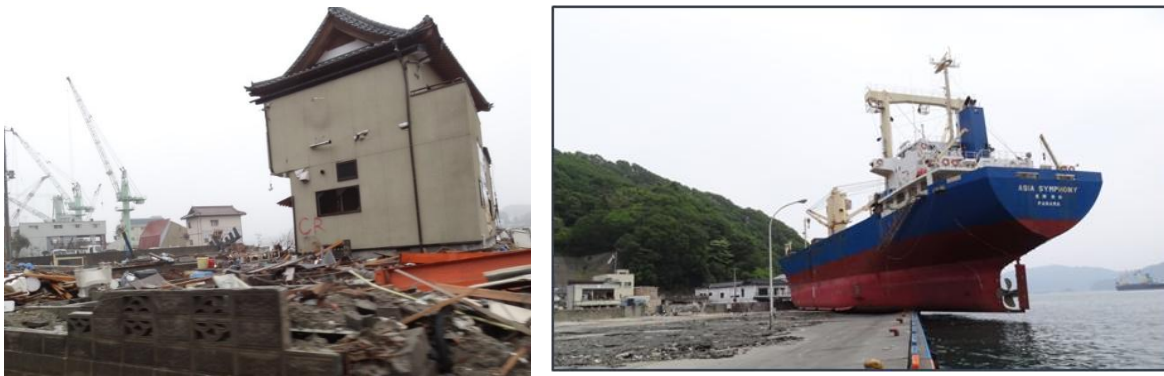
As tsunami waves pass through the opening of a breakwater, its flow velocity increases considerably causing erosion of breakwater mounds and creating eddies. Tsunami induced uprush and backwash flows with high velocities can cause change in seabed topography. As observed by the field investigations of different researchers, some of the breakwaters in Japan were damaged due to scour that occurred near the base of them after the 2011 tsunami. Along with scour, sediments deposits are also created by tsunami mainly at around the centers of inner port regions. Sediments introduced into harbors causes siltation inside the harbor. The extent of the damage to the Kesenuma Port and Kamaishi Port can be clearly seen in Figure 13.

Figure 133: Kesenuma (Left) and Kamaishi Port (Right) (Yalciner et al., 2011).

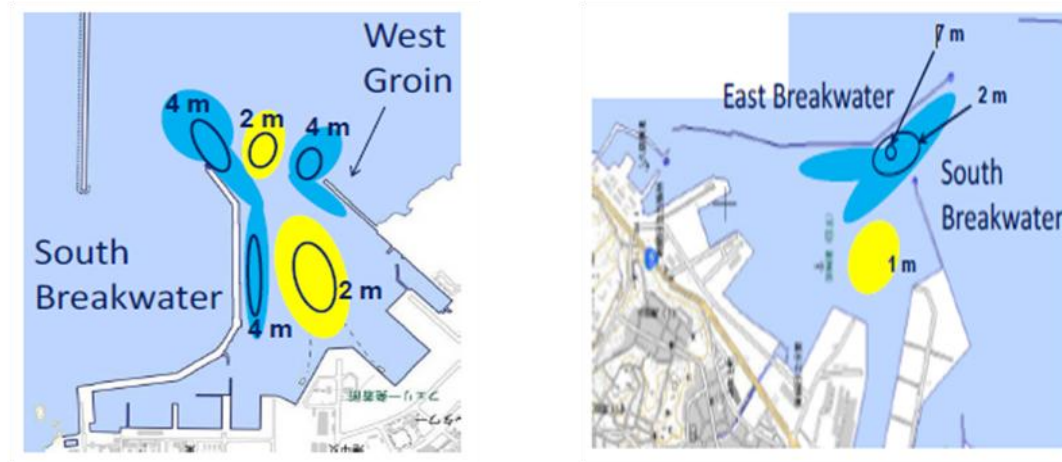
After the GEJE, scour was occurred between the gaps of breakwaters of both Hitachi Port and Oarai Port along with accumulation at inner ports (PIANC, 2014) (Figure 14). The maximum depth of scour at Hitachi Port of which has a gap width of 280 m, was 7m whereas at Oarai Port the scour depth reached 6 m. Due to the wide gap width of Oarai Port which is 430 m, an accumulation also occurred around the center of the gap.

Figure 144: Hitachi Port (Left) and Oarai Port (Right) (dark blue: scour, yellow: accumulation) (PIANC, 2014).

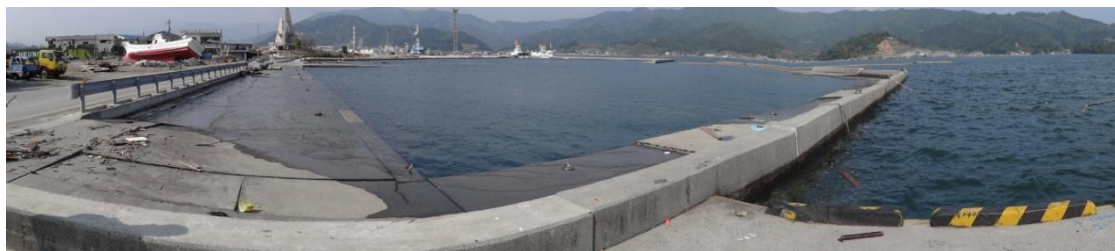
The tsunami eroded soil materials of many wharfs and washed out pavements of aprons. Sheet pile quay walls swelled and upper structures of the quay walls were shifted. Other facilities that were damaged or lost include mooring posts, lights, navigation aid signs and steel fences. Moreover cargo handling equipments such as loading cranes, gantry cranes, and winches were also damaged due to the tsunami. Some examples of damage that the GEJE created at the Ofunato Port and the Sendai Shiogama Port in Japan can be seen in Figure 15 and 16.

Figure 15: Tsunami damage and ground subsidence at Ofunato Port (Yalciner et al., 2011).

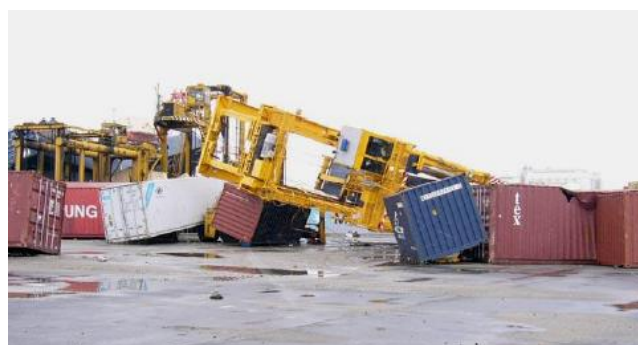
Figure 16: Damage to cargo handling machine at the container terminal of Sendai Shiogama Port (Photo courtesy: Y. Fukunaga).

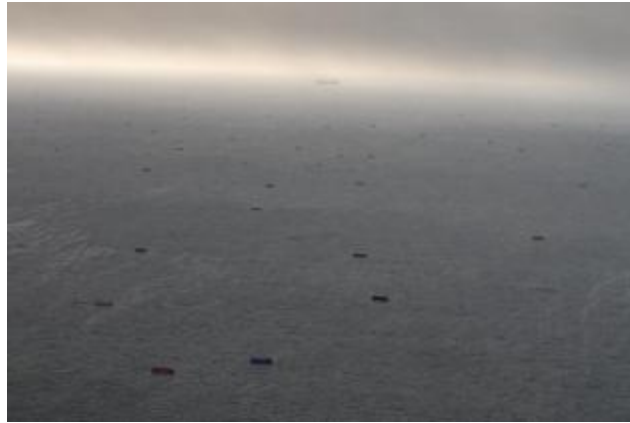
Figure 17: Aerial view of containers on the sea surface of Sendai Bay following the Tohoku tsunami (Kumagai, 2012)

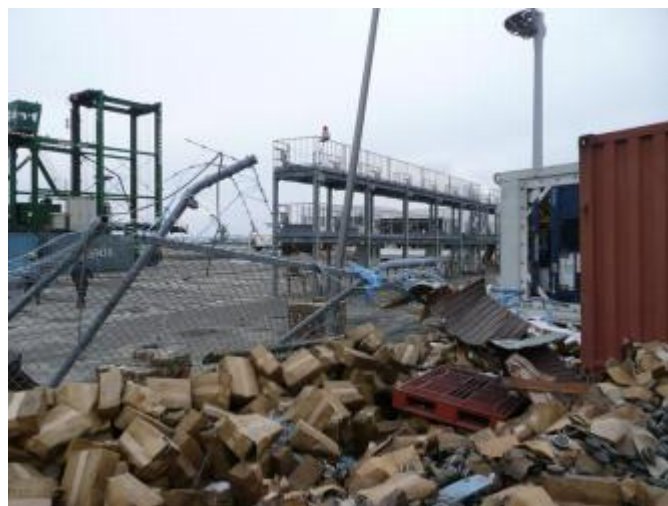
Structures such as perforated fences can help prevent containers to drift during a smaller wave attack however during the GEJE installed fences were also damaged. Figure 18 shows the damaged and broken wire fences at the Hachinohe Port.

Figure 18: Damaged wire fence on March 16, 2011 at the Hachinohe Port (Kumagai, 2012).

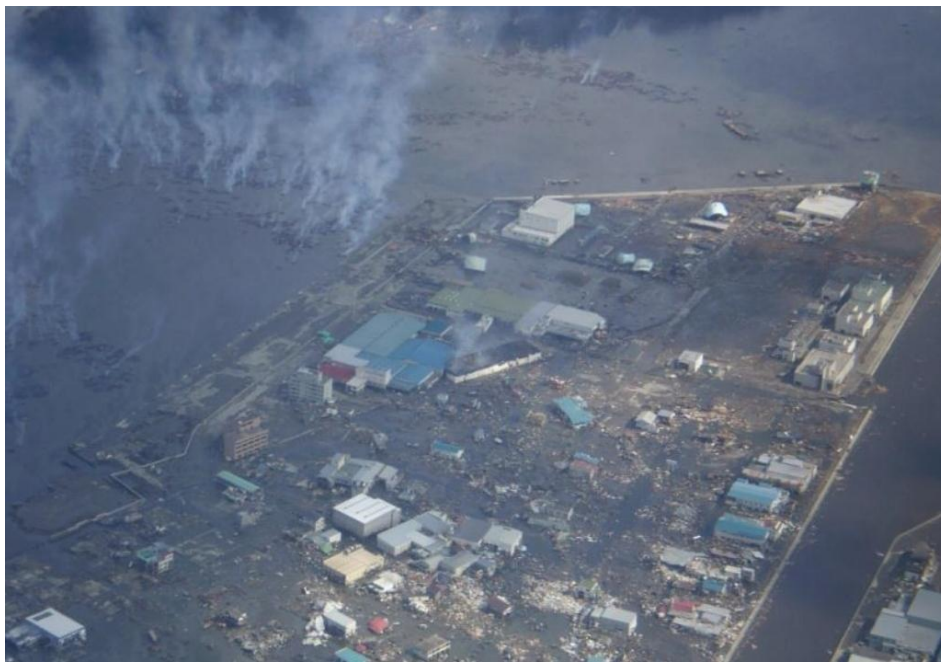
For outdoor tank storage facilities tsunami with a height of 3-5m caused damage to pipeline or accompanying equipment but not to tank itself. When tsunami height was over 7m, tanks and accompanying equipment faced extensive damage. In Kesennuma City where 9m tsunami was encountered, 21 of 23 oil tanks located near the shore were damaged or swept away resulting in a 12,810kL oil spill. In many of the swept tanks heavy oil was stored. The large scale fire on the sea surface (as shown in Figure 19) might have caused or enhanced by the oil spilled at sea. On the contrary, oil storage tanks in Kamaishi City survived the tsunami despite the 9m wave height.

Figure 19: Fire on the sea surface (PIANC, 2014).

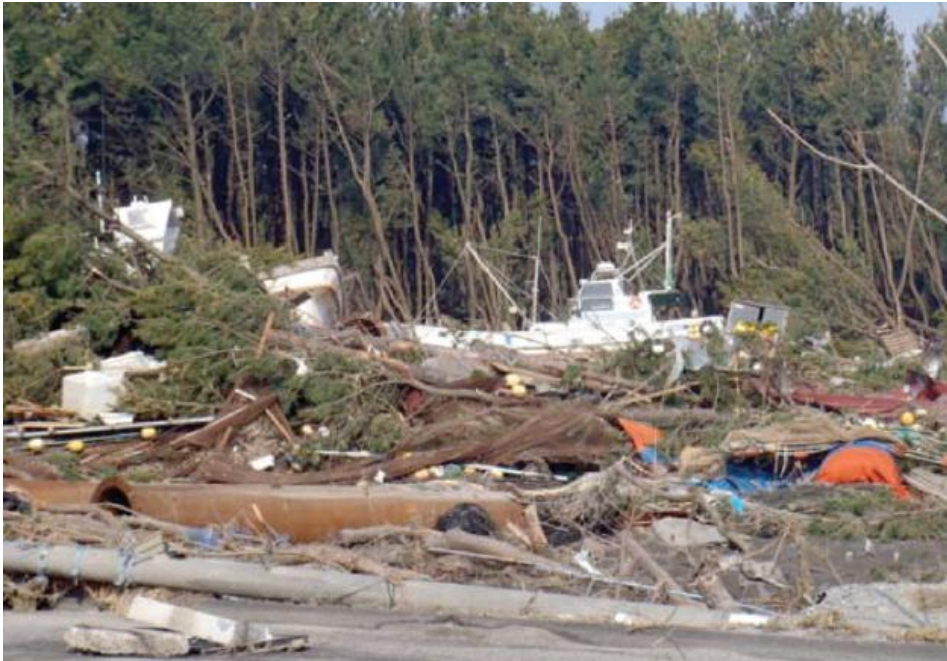
As an island country with a coastline of approximately 34000 km, Japan has been developing greenbelts for more than four centuries. After the GEJE 3,660 hectares (ha) of the greenbelt were damaged, 1,069 ha of this suffered damage more than 75 percent. However it has seen that greenbelts reduced the impact of tsunami by delaying the arrival time of tsunami and holding drifting debris (Figure 27).

Figure 27: The forest captures a floating ship (World Bank KN 2-8, 2012).
